Moisture in building envelopes

Application Note

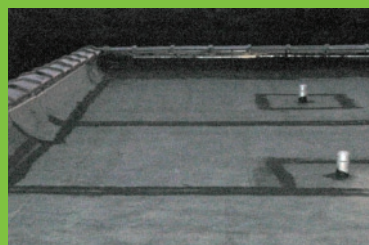
Cool areas on this roof exposure probably indicate moisture buildup. Mark with tape and investigate with core samples.
